Navajo Abandoned Uranium Mine

Site Screen Report

Mine Name: Jeepster No. 1
Mine IDs: 121

August 2011

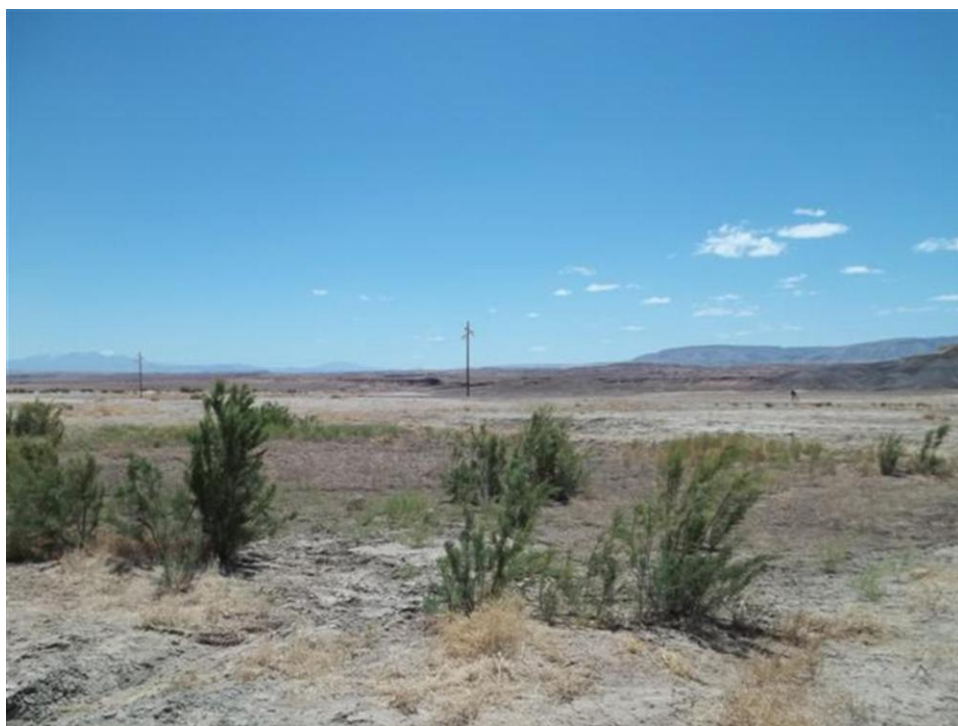
Photo 2: Mine Site #121; Dry pond

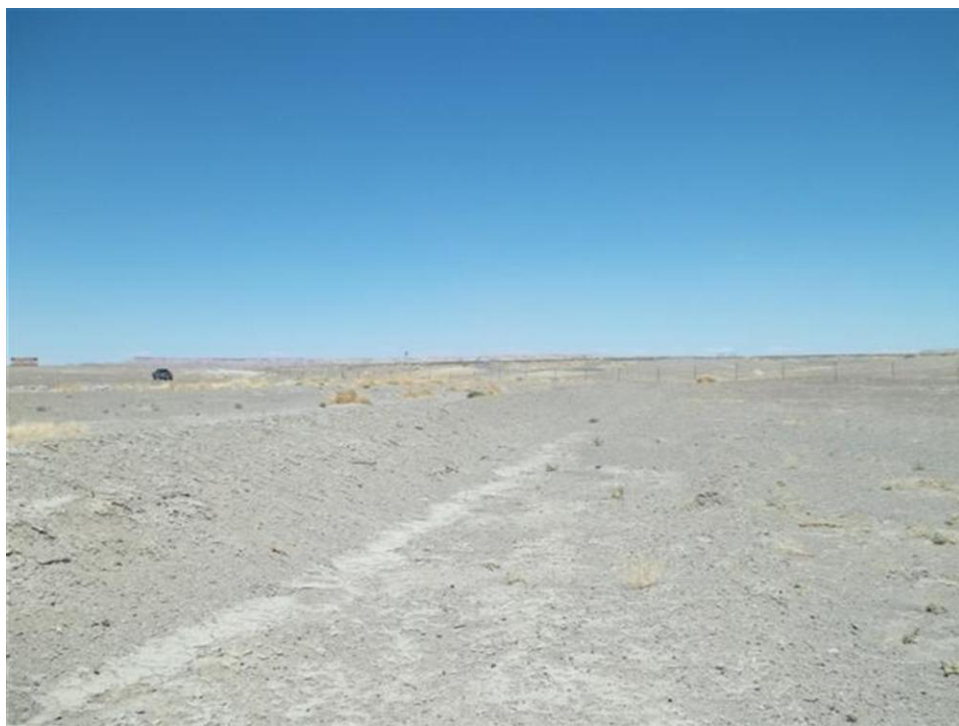
Photo 3: Mine Site #121; Berm area

Diversion reclamation berm

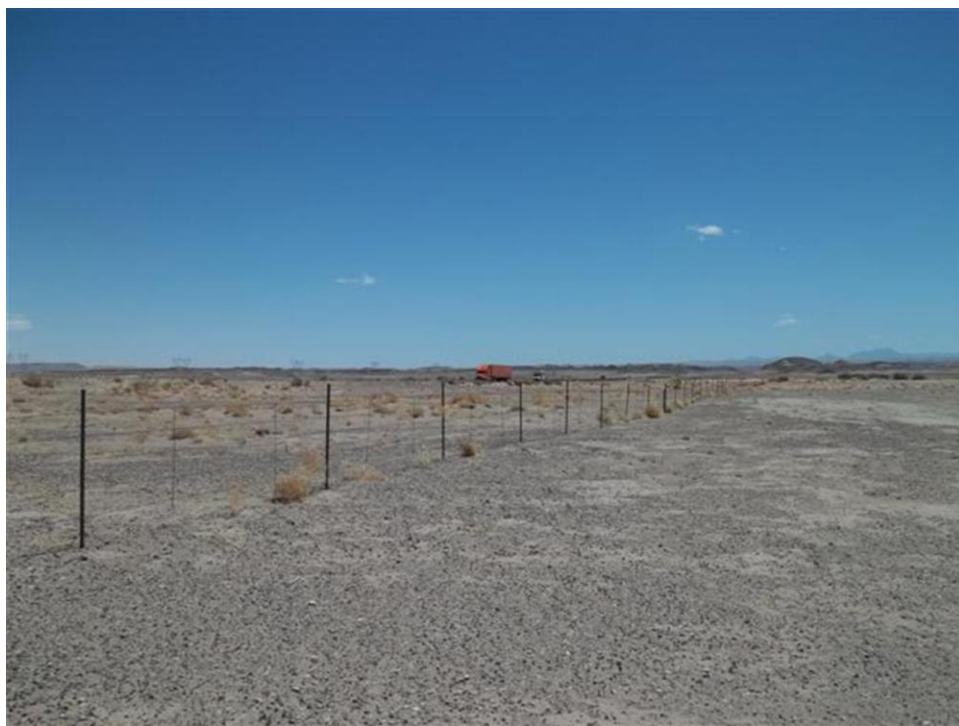
Photo 4: Mine Site #121; East edge of site and Hwy 89

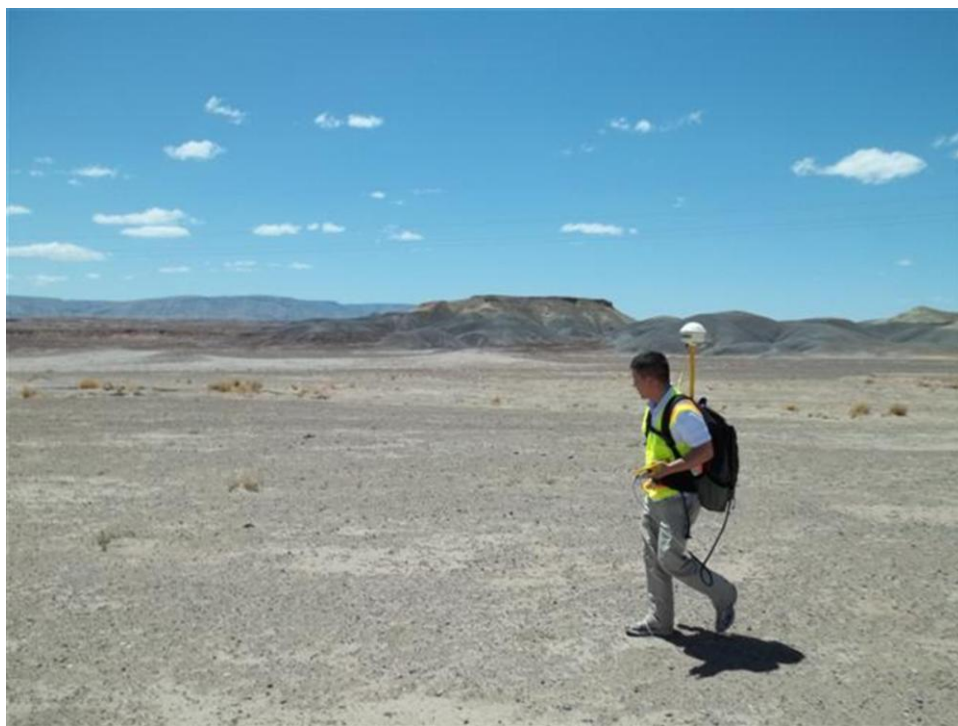
Photo 5: Mine Site #121; West edge of site

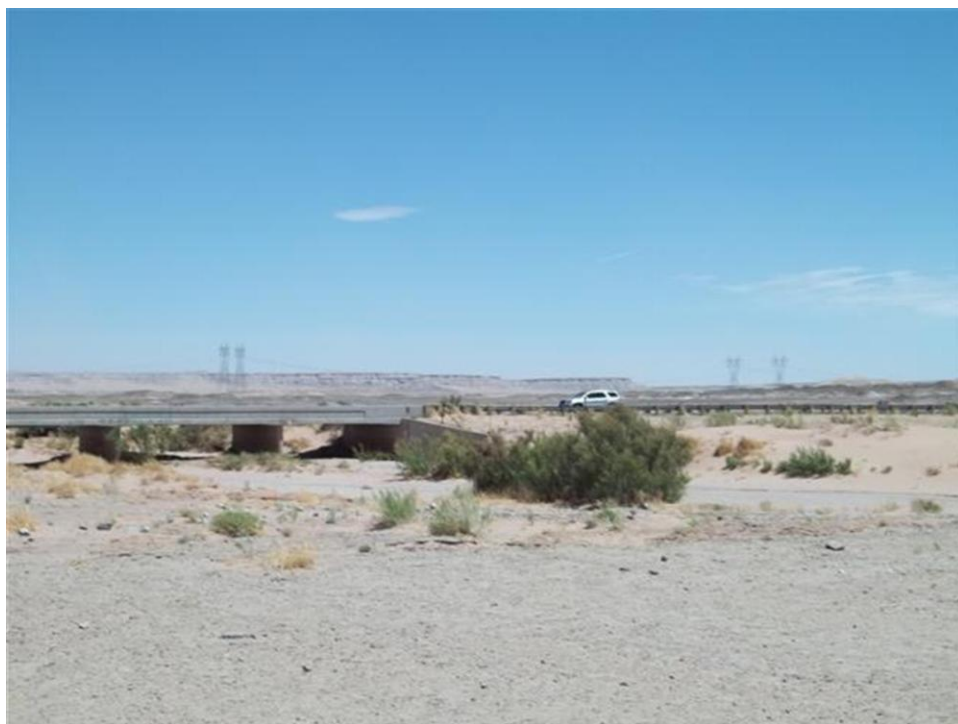
Photo 6: Mine Site #121; Drainage at south end and Hwy 89

0.25 miles to 4 miles: Seasonal tributary to Little Colorado River approximately 0.5 mi of site

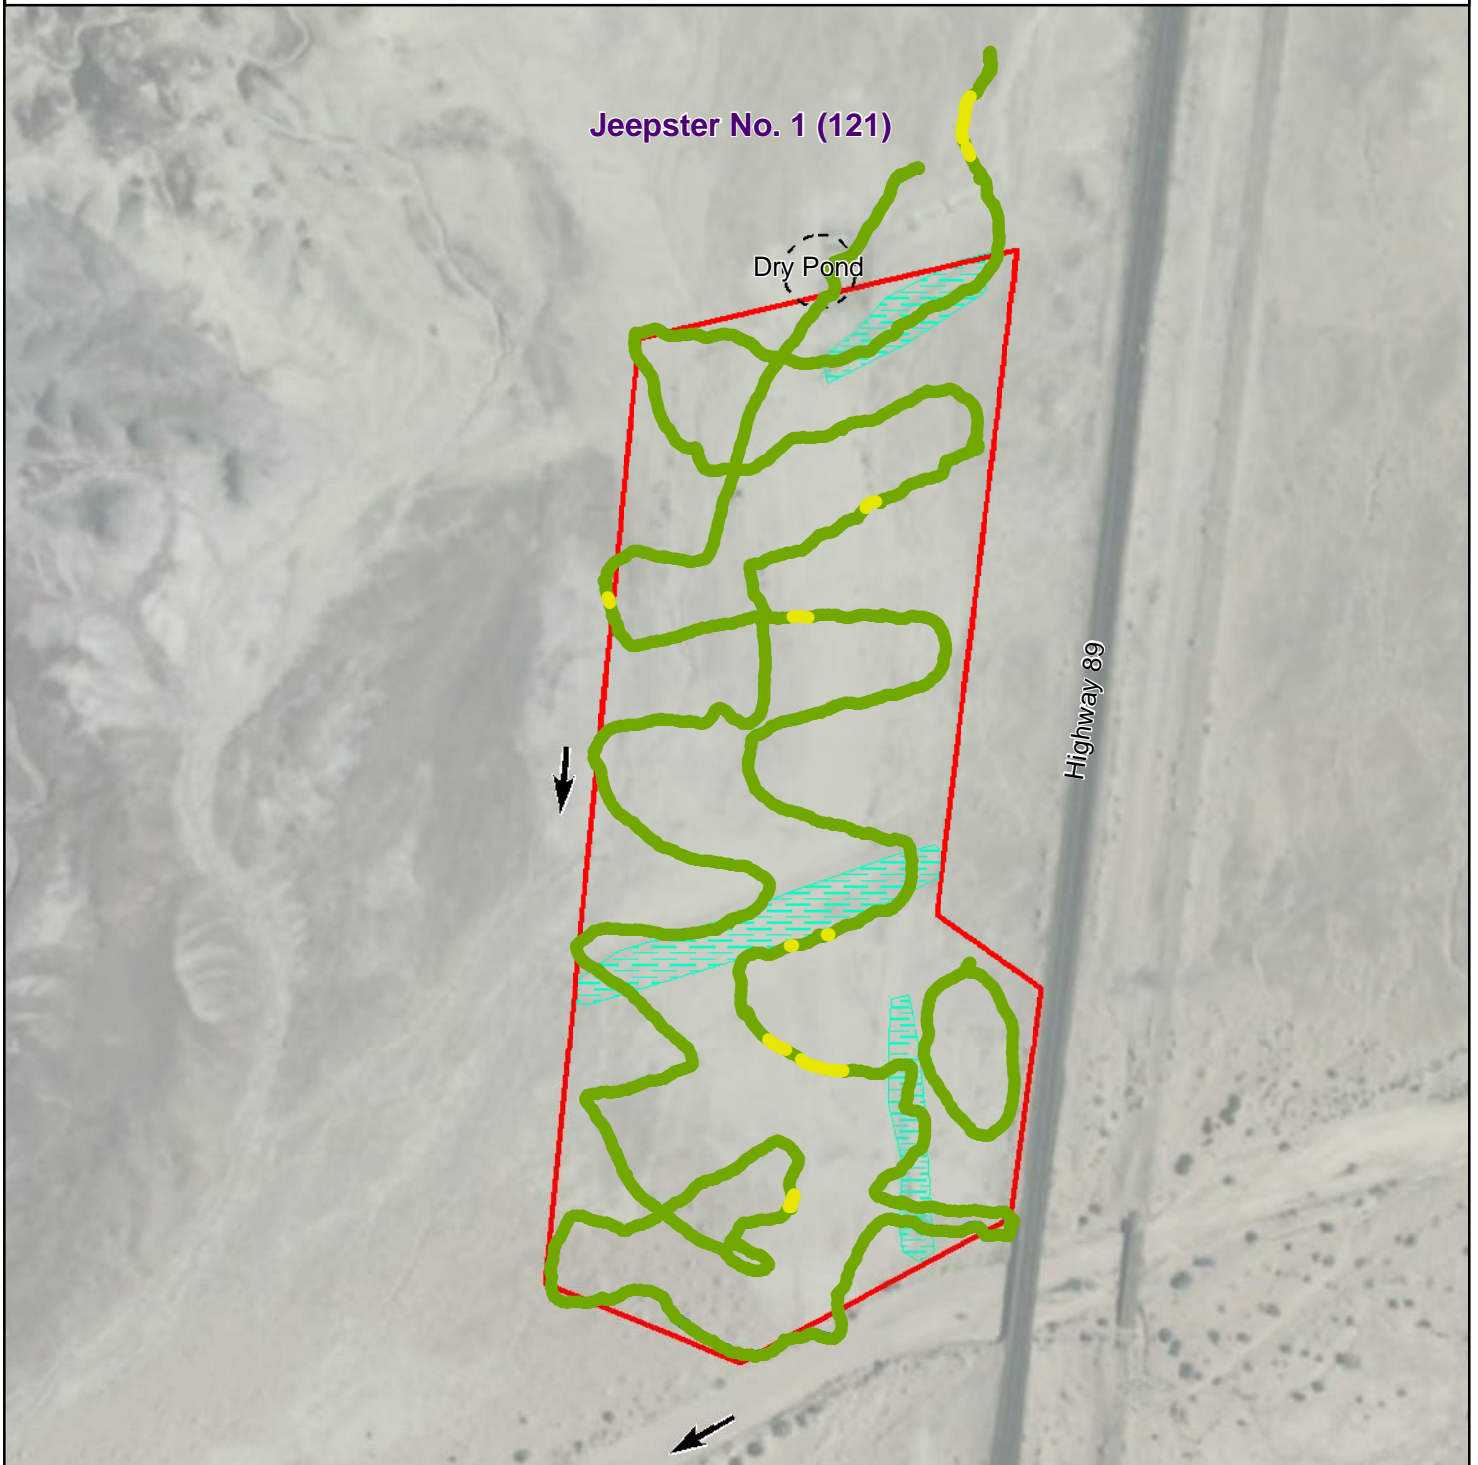
**Figure 2 - Gamma Radiation Measurements
Jeepster No. 1 (121)
Coalmine Mesa Chapter, Navajo Nation**

- 0 - 10,000 cpm
- 10,000 - 25,000 cpm
- 25,000 - 50,000 cpm
- 50,000 - 100,000 cpm
- 100,000 - 250,000 cpm
- 250,000 - 500,000 cpm
- 500,000 - 1,000,000 cpm

Measured as counts per minute (cpm) Average background 15,489 cpm

A total of 3,071 gamma radiation measurements were collected from the mine site, ranging from 8,961 cpm to 46,736 cpm. Measurements collected in the vicinity of the reclamation area were found at a maximum level of approximately 45,000 cpm. The measurements are represented in Figures 1 and 2.
